04/28/88 Aloha Airlines

Report Number NTSB/AAR-89/03

Report Title Aircraft Accident Report--Aloha Airlines, Flight 243, Boeing 737-200, N73711, near Maui, Hawaii, April 28, 1988

Report Type Aircraft Accident Report April 28, 1988

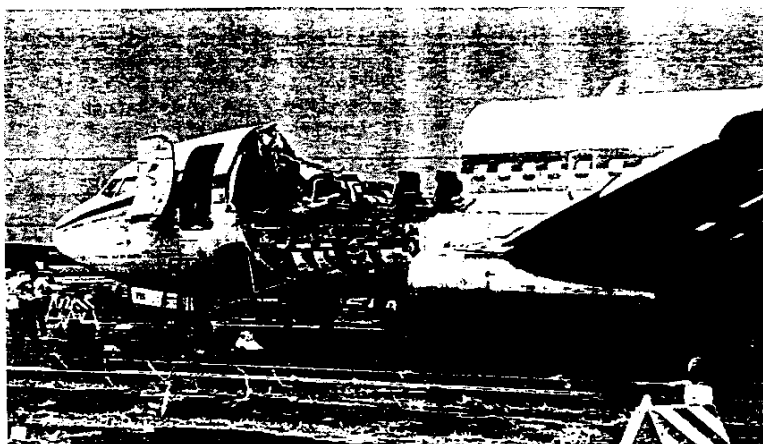
Figure 2a.--General view, left side of forward fuselage, N73711

A major portion of the upper crown skin and structure of section 43 separated in flight causing an explosive decompression¹ of the cabin. (See [figure 1](#) and [figure 2](#).) The damaged area extended from slightly aft of the main cabin entrance door, rearward about 18 feet to the area just forward of the wings and from the left side of the cabin at the floor level to the right side window level.

The area where the structure was missing extended from body station⁴ (BS) 360 aft to about BS 540, and circumferentially from just above the floor on the left side of the airplane (at S-15L), across the crown and down the right side to a position above the window belt (at S-10R). The structure from the top of the window belt to the floor on the right side was distorted severely and bent outward more than 90°. The skin had peeled in this area leaving the frames, stringers, and window forgings in place. On the left side below the floor level, the skin had peeled off the structure in large V-shaped areas.

Five consecutive floor beams⁵ at BS 420, 440, 460, 480, and 500 were broken all the way through. Also, the adjacent floor beams at BS 400 and 500A were cracked nearly all the way through. The fractures and cracks were slightly to the left of the airplane centerline. The frames at these same seven stations were broken on the left side just below the floor beams. Most of the center floor panels from BS 360 to BS 947 were displaced upward except in the overwing area. The right side cabin floor panels had not been displaced and little if any distress had occurred at the fastener locations for these panels. However, on the left side of the airplane between BS 400 and BS 500 along the inboard seat track, there was extensive floor panel displacement. The floor panels had displaced upward and had reached their maximum displacement of 4 inches at BS 440 (matching the displacement of the broken floor beams).

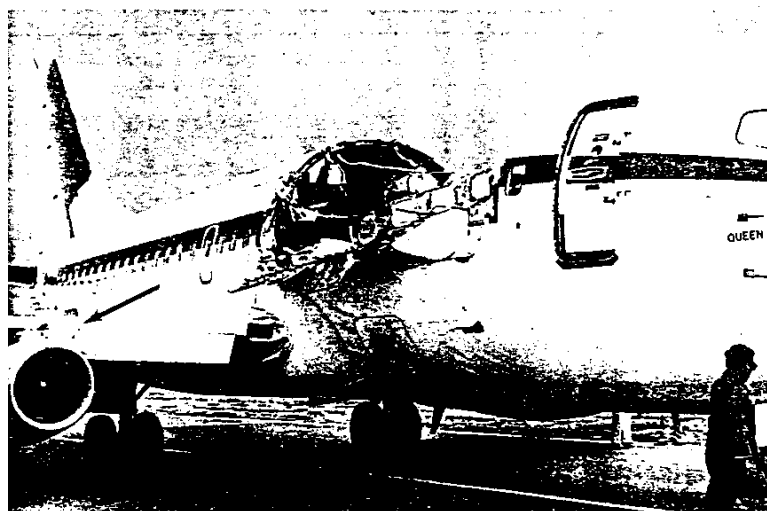
Figure 2b.--General view, right side of forward fuselage, N73711. Arrow marks fragments of S-4R lodged in the leading edge flap.

A fuselage section from BS 365 to BS 420 between S-4R and S-8R was trapped between the leading edge flap and inboard side of the right engine strut. This was the only significant piece of structure from the damaged area that was recovered. The recovered piece contained two skin repairs along S-4R. This section and several samples cut from the remaining fuselage skin were submitted to the Safety Board's Materials Laboratory for further analysis. (See 1.16.3 Materials Laboratory Analysis.)

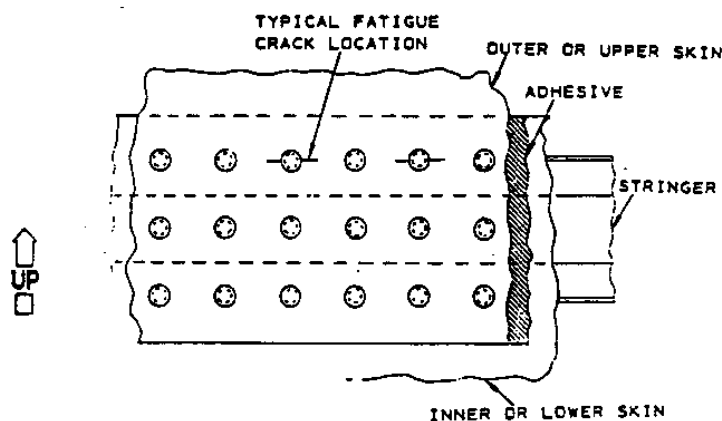
FIGURE 5. FATIGUE CRACK LOCATION

Since the release of Revision 2 an operator has reported multiple fatigue cracks on three airplanes which have accumulated 40,400/42,800 flight hours and 44,700/49,900 flight cycles. Cracks were located in the upper skin at stringer four (S-4), left and right, S-10 right and S-14 right, between Body Stations 360 and 907.

Therefore, Revision 3 was issued to up-grade this service bulletin to an "ALERT" status and to revise the repeat inspection thresholds for detecting fatigue cracking of the outer skin panel at the lap joint upper row of fasteners. Part I of SB 1039 Revision 3 dealt with "Corrosion Inspection" and Part II addressed "Fatigue Damage and Repair." The subject areas were lap joints at S-4, S-10, S-14, S-19, S-20, and S-24. Part III covered "Tear Strap Inspection and Repair" in the same structural areas as Part II.

- D. Areas where no fatigue cracks are found should be reinspected annually. Reinspection for fatigue cracks may be terminated by replacing the existing upper row of joint fasteners with standard protruding head solid fasteners per Part IV. However, a corrosion inspection program should be maintained.
